## CENTRAL VALLEY REGIONAL WATER QUALITY CONTROL BOARD

## **INSPECTION REPORT**

FACILITY: Stanislaus Almond Ranch, LLC, and Lake Road Grizzly Ranch, LLC

**INSPECTION DATE**: 25 March 2009

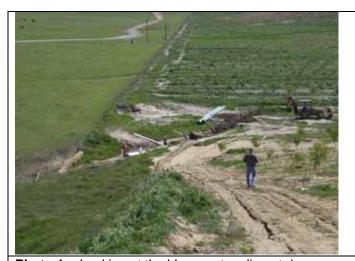
**Photo 1:** Looking at the blown out sediment dam.

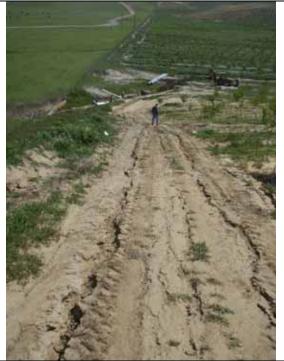
**Photo 5:** Rill erosion (from same location as Photos 1 and 2).

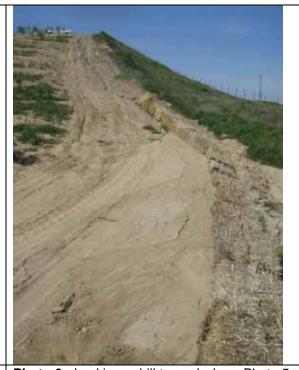
**Photo 6:** Looking uphill toward where Photo 5 was taken.

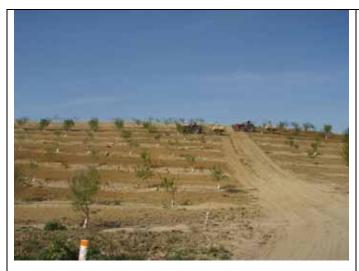
Photo 7: Spray rig spraying herbicide.

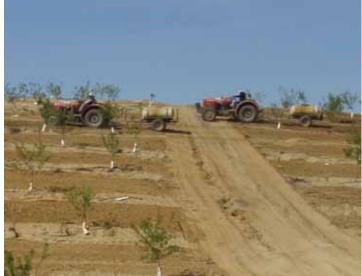
**Photo 8:** Close-up of Photo 7. Also note that between the rows was disked.
